San Pasqual Valley Unified School District

ASBESTOS INSPECTION REPORT – ROOF SURVEY

SAN PASQUAL VALLEY HIGH SCHOOL BUILDING 301 ROOF

ENCORP PROJECT NUMBER P24029.RES

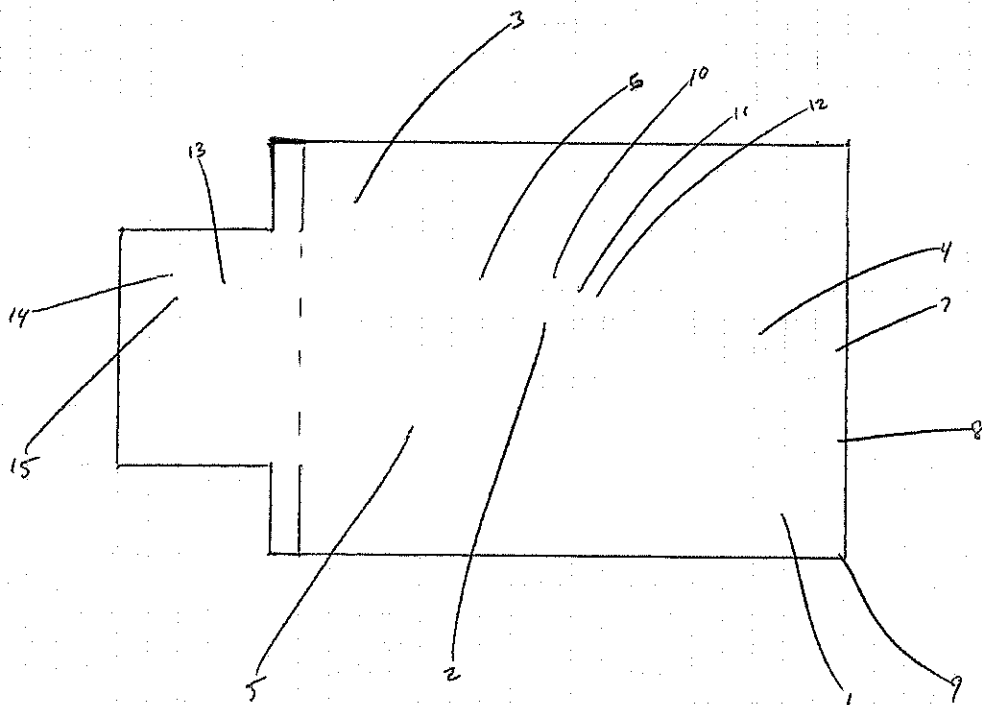
DESCRIPTION: San Pasqual Valley High School - BLDG 301

Material Description	Locations	Individual Sq Ft	Total Sq Ft	Condition	Qty of Samples	Sample #'s
Roof Roof Core	Building 301 Main Roof		7700φ	G	3	1-3
Grey/Black Mastic			40φ			4-6
Roof Edge Mastic			20φ			7-9
Black Mastic			10φ			10-12
Vapor Barrier/ Mastic	Clay Tile Roof		1200φ			13-15
